ADVANCED CLAIM INSPECTIONS

LADDER ASSIST

Claim #: <u>EXAMPLE</u>	Hail	Wind	BT	Date: <u>8/27/2015</u>
Homeowner: <u>EXAMPLE</u>	N: \emptyset	7	PASS	Ladder Now Russ Carroll
Address: <u>EXAMPLE</u>	S: \emptyset	8	PASS	Inspector: _____
Adjuster: <u>EXAMPLE</u>	E: \emptyset	6	N/A	Phone: <u>(770) 743-7375</u>
	W: \emptyset	1	PASS	Email: <u>Rcarroll@laddernow.com</u>

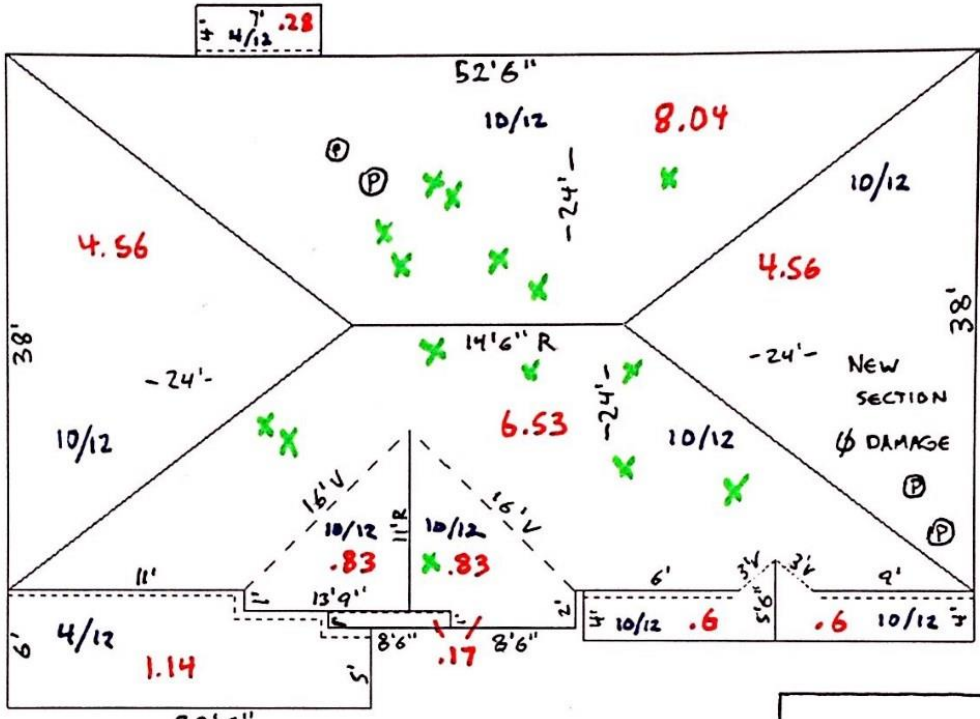
- A) 52'6" x 24' x 2 = 25.2 SQ
 - B) 1' x 13'9" x 2 = .28 SQ
 - C) 1' x 8'6" x 2 = .17 SQ
 - D) 4' x 15' x 2 = 1.2 SQ
 - E) 7' x 4' = .28 SQ
 - F) 20'6" x 6' = 1.23 SQ
- Total SQ = 28.34 SQ
Total 2 Story = 25.65 SQ
Total 10/12 = 26.85. SQ

Max Hail Diameter: <.5" Notes: ROOF APPEARED TO BE 10-12 YEARS OLD
